Manhole Inspection Summary

Manhole # S11MM1008MH

Insp Date: **11/14/08 1:32 PM**

Location Address: **3201 VIRGINIA AVE**

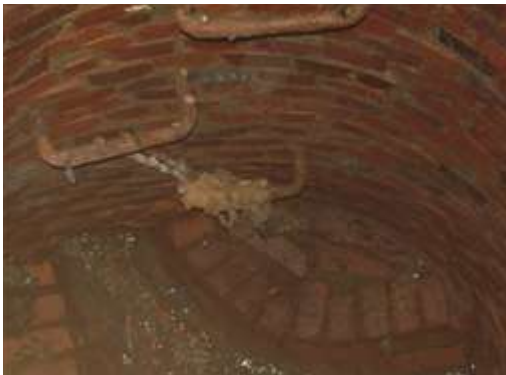
Defect 2

☒ **Evidence Of Surcharge** Depth: **3** (ft.) ☐ Active Surcharge Present

EVIDENCE OF ASUR

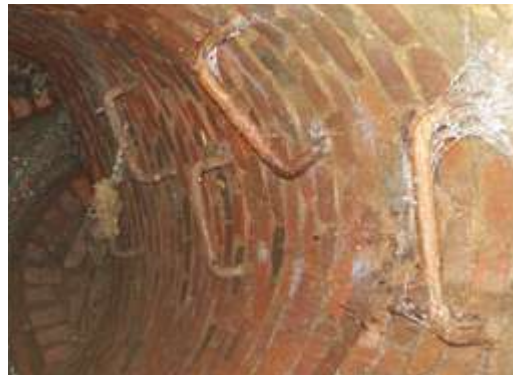
Defect 1

Count: **5** Missing: **0** ☒ **Corroded**

CORRODED STEPS

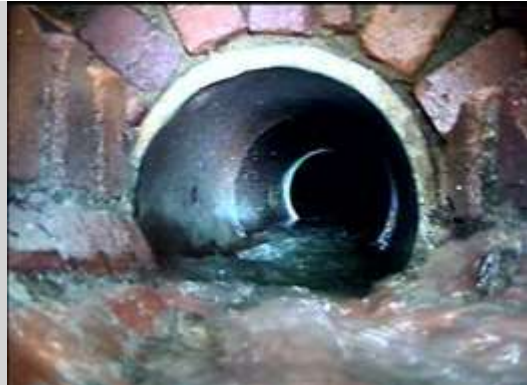
12 O'Clock Outflow

10 in. Circular Gravity Sewer
Pipe Out @ 12 O'Clock

Pipe Height: (in.) Direct
Pipe Material: **Clay** ☐ Pipe Lined
Invert Depth: **9.55** (ft.) Flow Characteristics: **Fast**
Deposits: ☒ None ☐ Mud ☐ Sludge ☐ Debris ☐ Grease
Silt Depth: (in.) Deposits Extent:
Infiltration: **None** Pipe Seal Cond: **Sound**

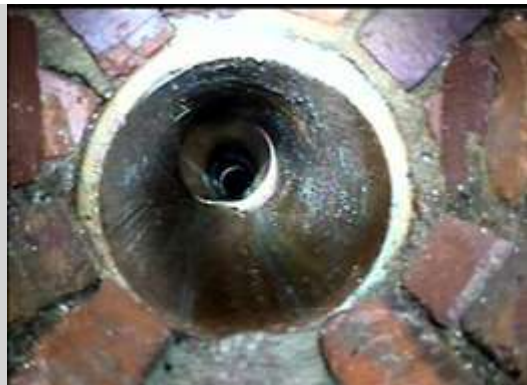
3 O'Clock Inflow

10 in. Circular Gravity Sewer
Pipe In @ 3 O'Clock

Pipe Height: (in.) Direct
Pipe Material: **Clay** ☐ Pipe Lined
Invert Depth: **9.39** (ft.) Flow Characteristics: **Slow**
Deposits: ☒ None ☐ Mud ☐ Sludge ☐ Debris ☐ Grease
Silt Depth: (in.) Deposits Extent:
Infiltration: **None** Pipe Seal Cond: **Sound**

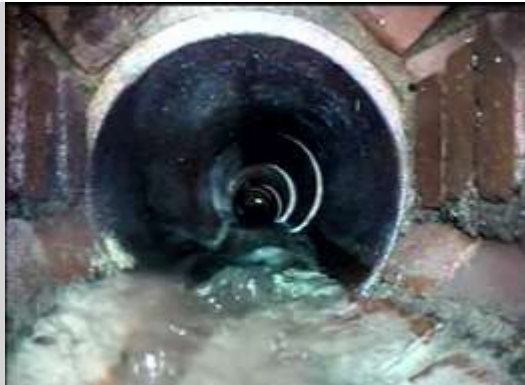
6 O'Clock Inflow

10 in. Circular Gravity Sewer
Pipe In @ 6 O'Clock

Infiltration: **None** Pipe Seal Cond: **Sound**

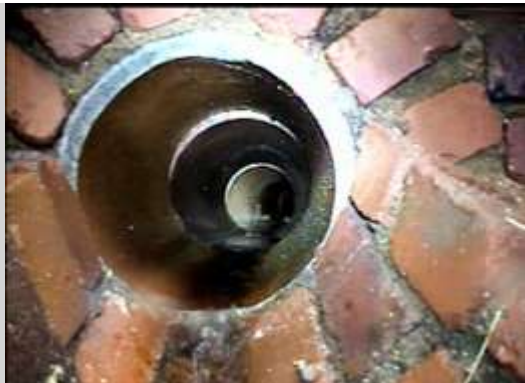
9 O'Clock Inflow

8 in. Circular Gravity Sewer
Pipe In @ 9 O'Clock

Infiltration: **None** Pipe Seal Cond: **Sound**
